NATIONAL WESTERN STOCK SHOW  
ENVIRONMENTAL ASSESSMENT REVIEW

August, 1990

Reference: National Western Stock Show  
Environmental Assessment Report Review  
National Western Stock Show Additions  
Southwest of 47th Avenue and Humboldt Street  
Denver, Colorado

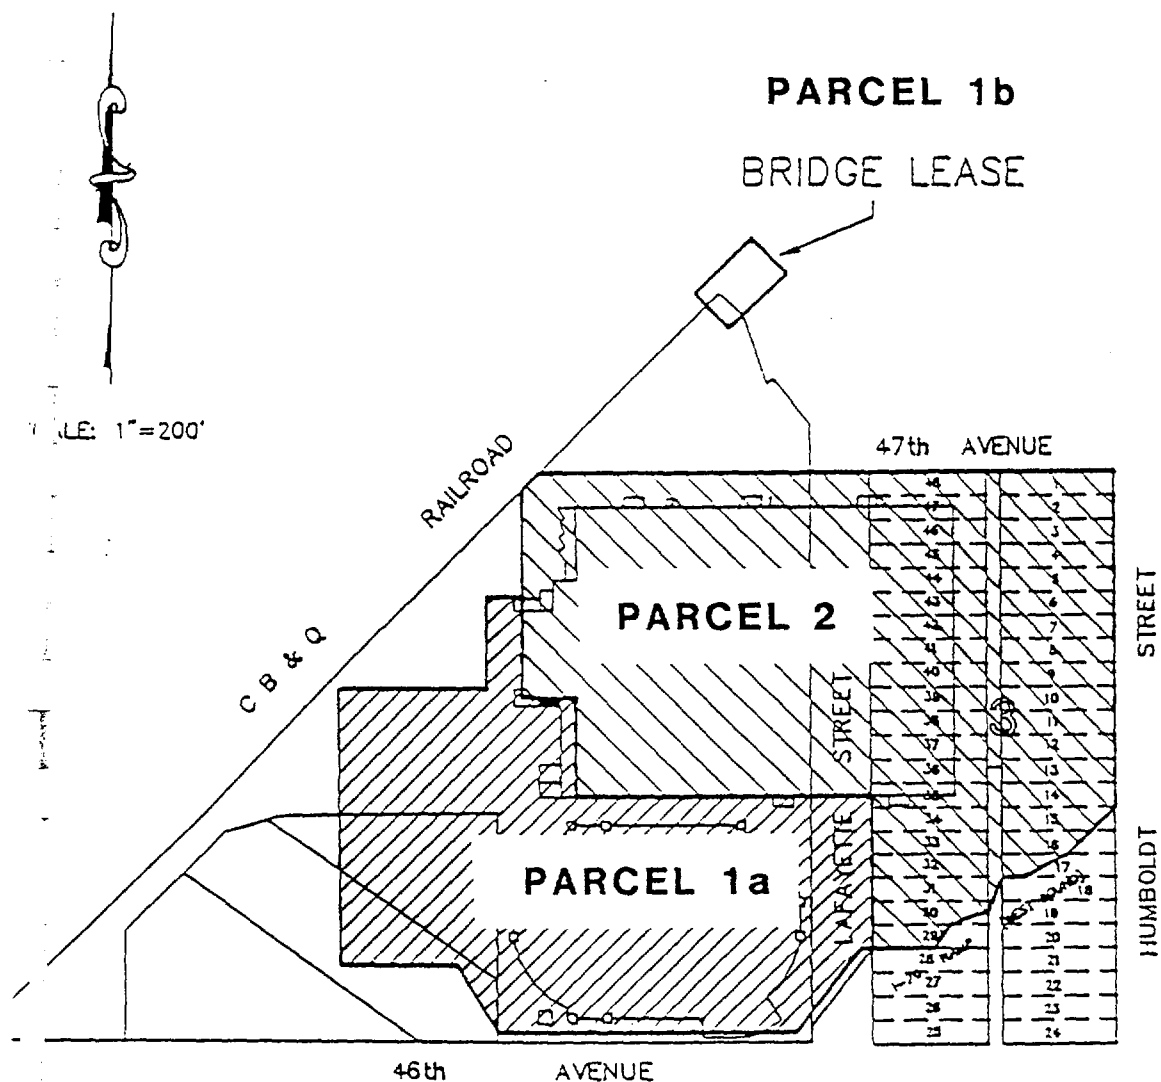
FIGURE 1

The location of the site is shown on Figure 1. The subject of this review is limited to the areas identified as Lease Parcel 1a, 1b and Lease Parcel 2. These specific properties are the subject of a lease/sub-lease agreement between the National Western Stock Show Association and the City and County of Denver. Other areas adjacent to Lease Parcels 1a, 1b and 2 are discussed in this report only if conditions on these properties could directly or indirectly impact the subject parcels.
